Inspection Report

Minerals Regulatory Program

Mine Name: Italian Tan
Operator Name: Quality Building Stone

Permit number: S/007/0038
Inspection Date: April 25, 2012
Time: About 4:15-4:30 PM

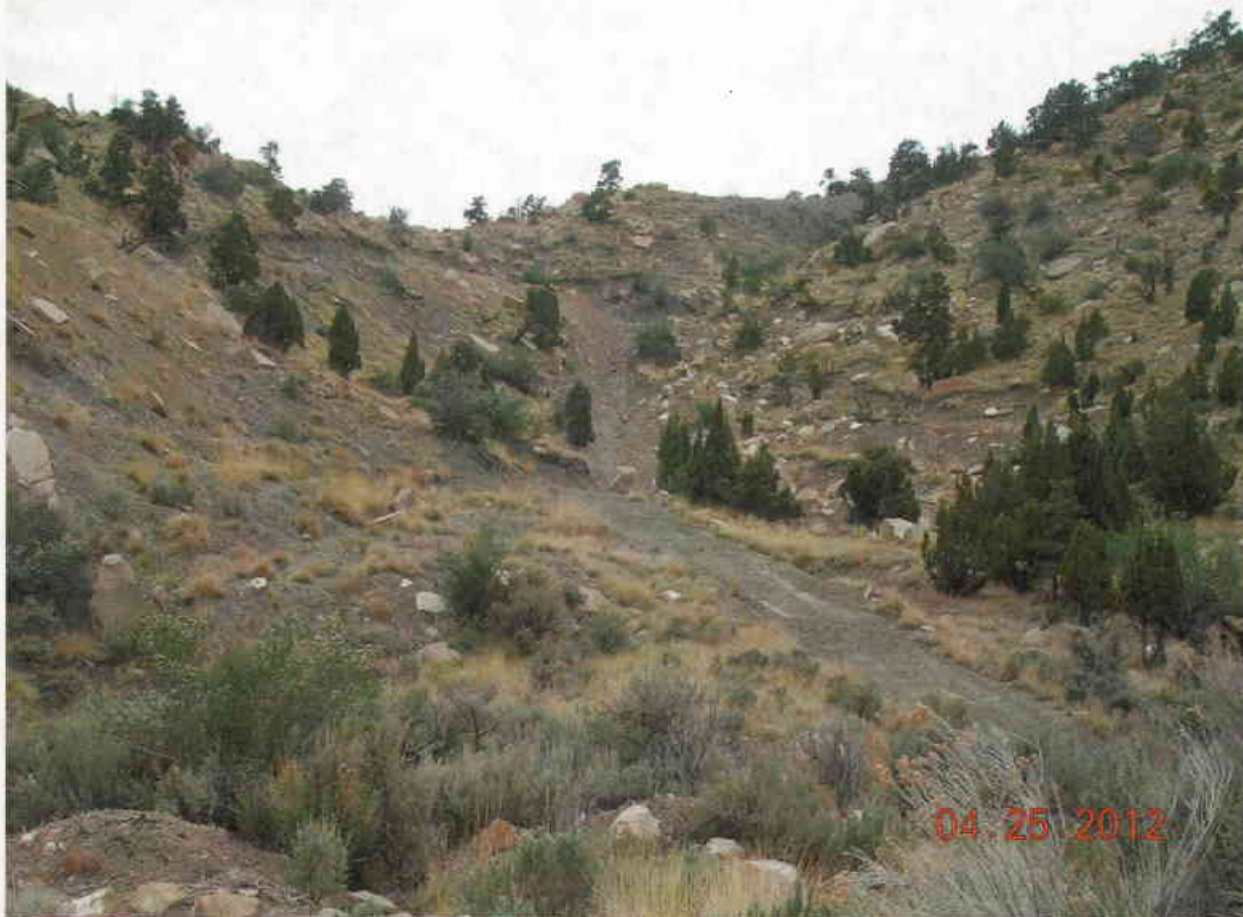
In accordance with the desires of Utah Railway, the operator did not reclaim a road that goes to the top of the hill, but there is a drainage that was also not reclaimed (Photos 1 and 2).

Photo 1. The drainage discussed in the inspection report is in the center of this photo. On the left side of this photo one can see the cut formed by upper portion of the switchback road.

I believe the drainage area shown in Photos 1 and 2 is not part of a road system and that it needs to be reclaimed, but the Division needs to try to do a site visit with a representative of Utah Railway to confirm

this. The operator left a road, so I do not believe there needs to be a second access route to the top of the hill. The drainage is too steep to be considered a road, and there are also two large rocks at the bottom of the drainage that would preclude it from being used as a road.

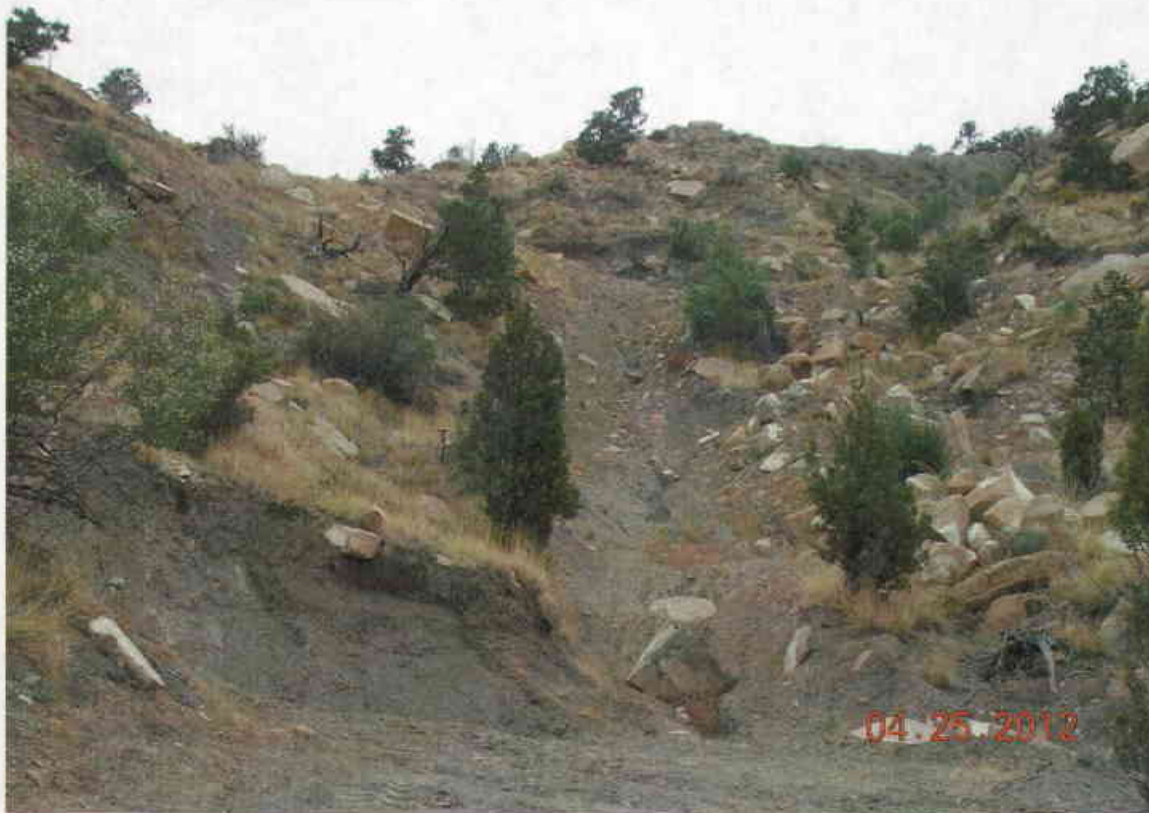
Photo 2. Another view of the drainage. Note the rocks at the bottom. These rocks and the steepness would preclude anyone from using the drainage as a road.
